Repairhints

Communicator 9000/9000i RAE/K-1/4

The purpose of this document is to provide some further service information for NOKIA Communicator 9000/I. It contains a lot of collected tips and hints to find failures and repair solutions easily. It also will give support to the inexperienced technicians. Saving process time and improving the repair quality is the aim of using this document. We have built it up based on fault symptoms (listed in "Contents") followed by detailed description for further analysis. It is to be used additionally to the service manual and other service information like Service Bulletins, for that reason it doesn't contain any circuit descriptions or schematics.

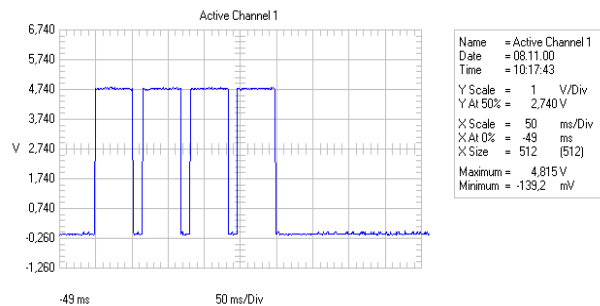
VSIM after switching on the phone without SIMcard. E 400 pulses up VSIM four times to an amplitude of 5 Volt.

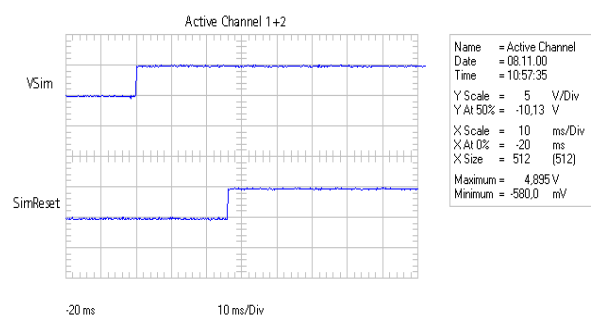
SIMReset is low-active, that means that the Simcard will be reseted when SIMReset is 0 Volt.
This is the case after switching on the phone. While VSIM is already high, SIMReset keeps low for a few milliseconds – in this time the card will be reseted.

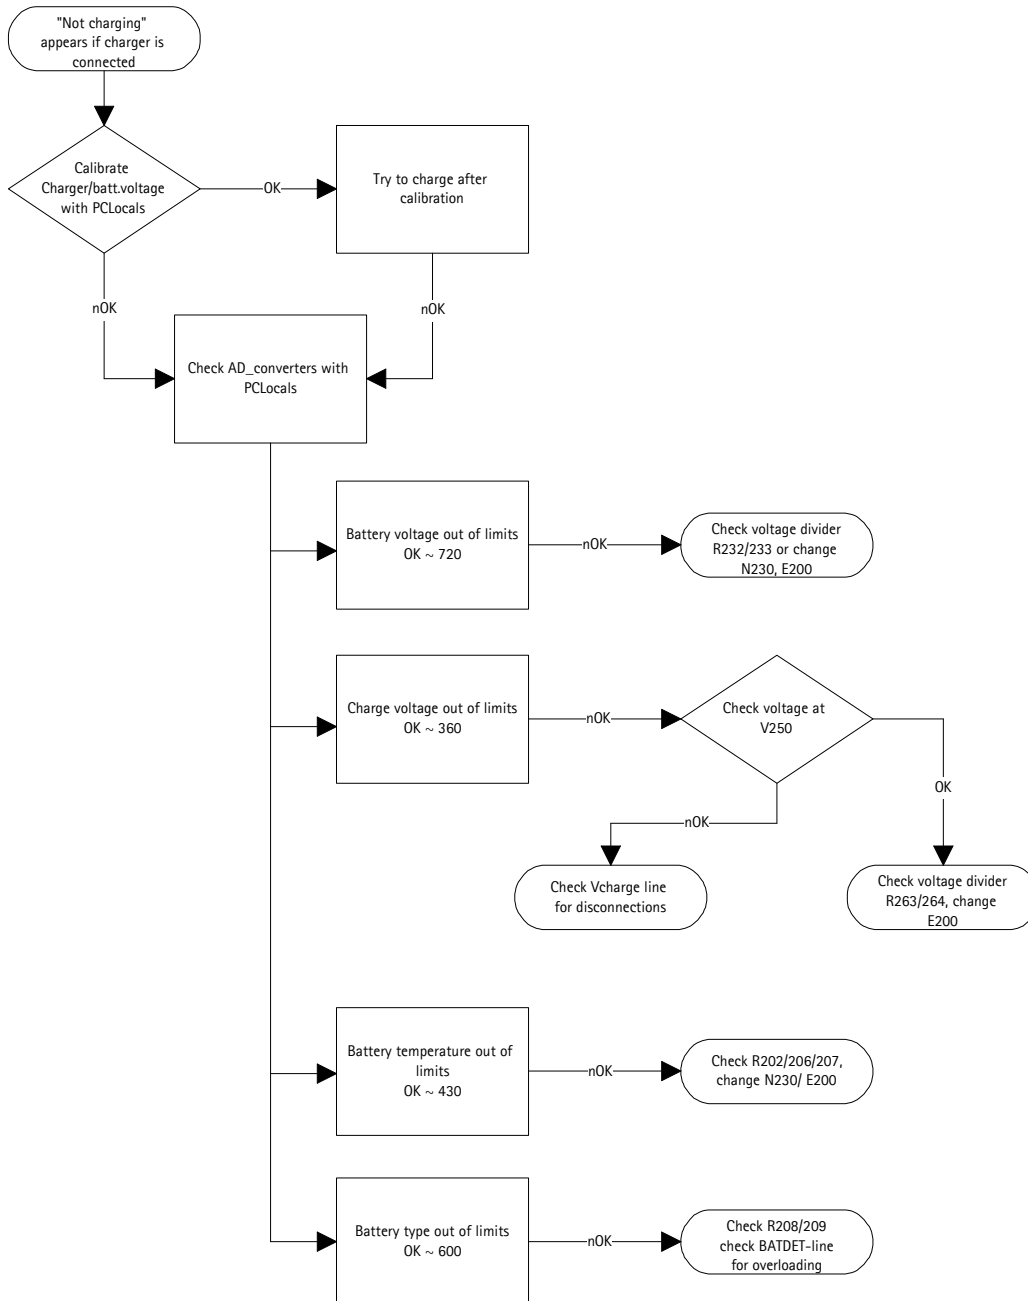
NOT CHARGING

Nothing happens if charger is connected

First check X121 and PAR-1 if soiled or oxidized.

Check Vcharge-line for disconnections. Charger-voltage is supplied via connector X121, over L970 / V970 (overvoltage-protection, located on PDA-board) to board-to-board connector X102/201 and from there to V250/251, which are responsible for the fault in most cases.

If charger-voltage is ok at V250 or fault persists after changing V250/251, check CHRDET at E400

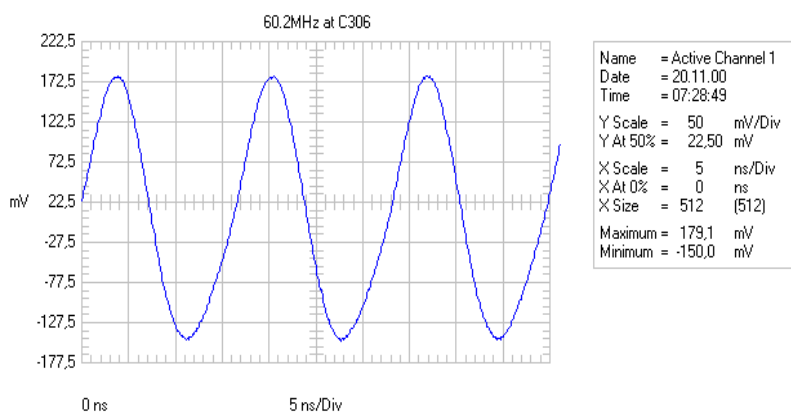
In case of Selftest failures which appears from time to time check DSP-oscillator. It is enabled by ASIC (Check E400 pin 88, 4.8V DC).
Critical parts are the crystal G300, coil L300 and transformer T300. If it is necessary to change the crystal, take care not to destroy L300, which is thermal sensitive!

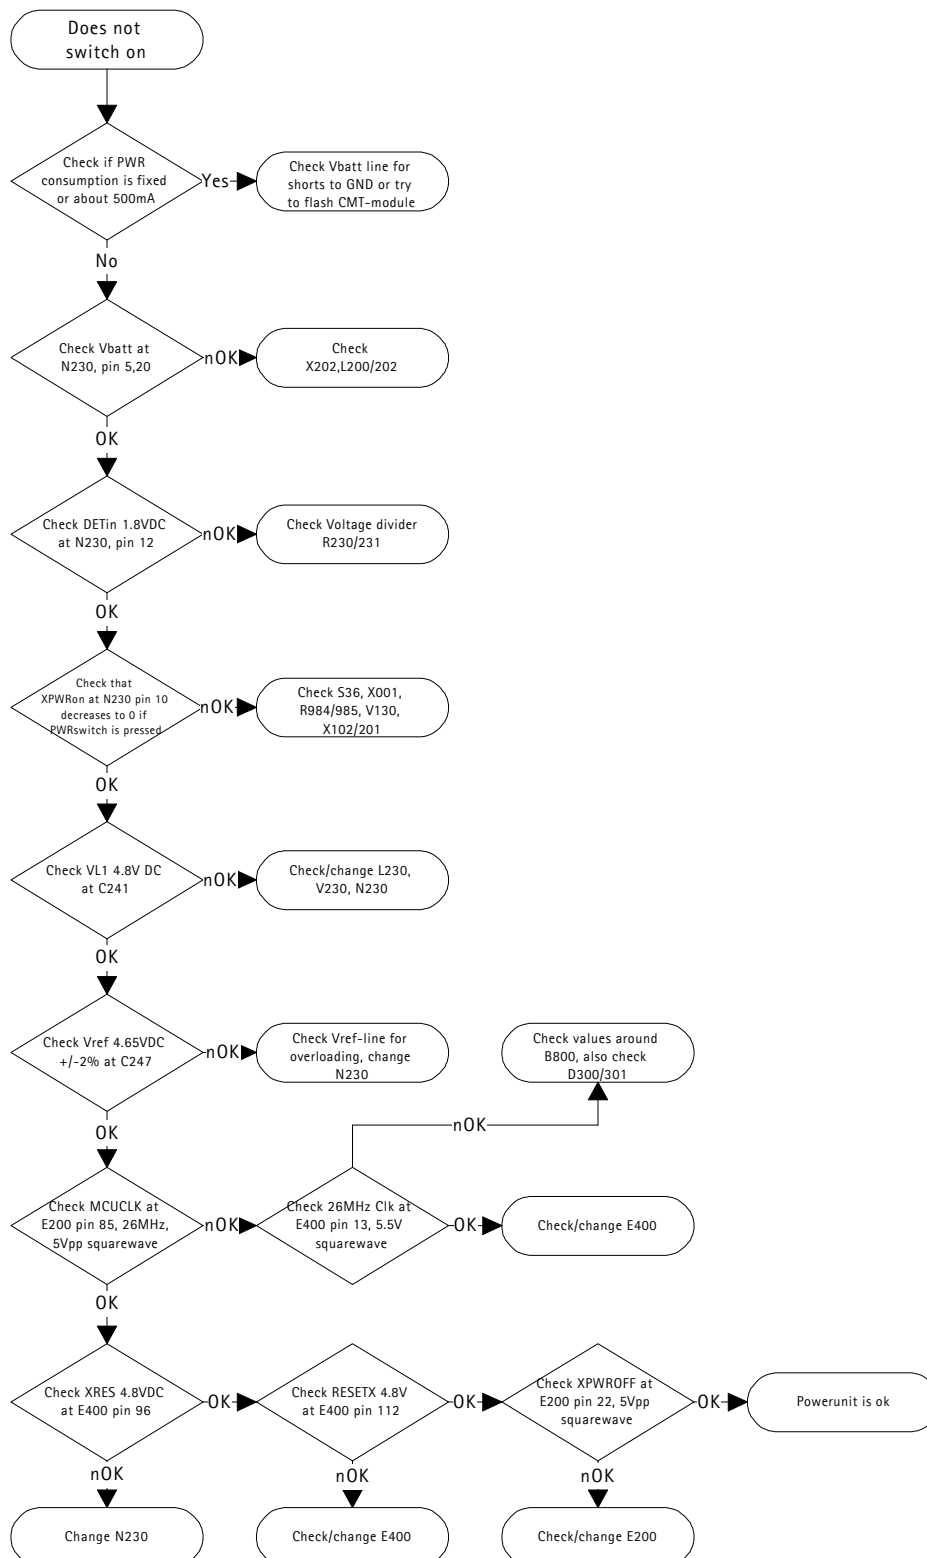
CMT DOES NOT SWITCH ON

In this case check first of all the fault with the normal battery, do NOT connect a service-battery to the phone. If the CMT-module does not switch on disassemble it and check resistance of capacitors C763 and C790-793. If resistance of every capacitor is ok, you can connect phone to a service-battery to check current consumption – the use of other tools may result in burnt traces !

Off state current should be $\leq 2\text{mA}$, sleep mode current $\leq 20\text{mA}$, call mode current varies between 200mA and 600mA (depends on TX powerlevel and lights).

If CMT does not switch on, it can also be necessary to update the CMT software.

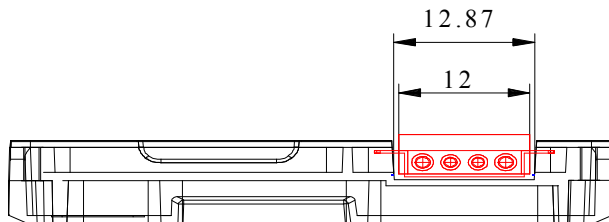
If the communicator intermittent switches off itself and the symptom can be reproduced by moving the battery sideways, check that the space between the right edge of connector X202 and the chassis is 0.5mm. If distance is not ok, try to correct it by opening screws of shield and chassis and push CMT-module to the left, check gap after tightening the screws. If this does not work, replace connector X202.

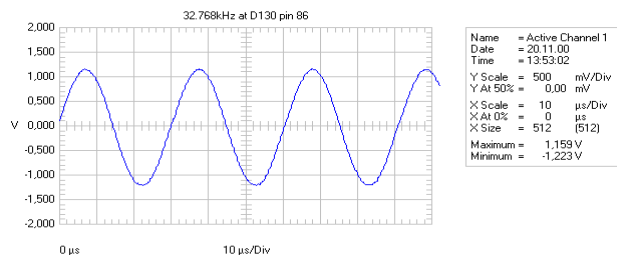
Check 32.768kHz sinewave at D130 pin 86. In most cases the crystal B130 is defect if signal is not ok.

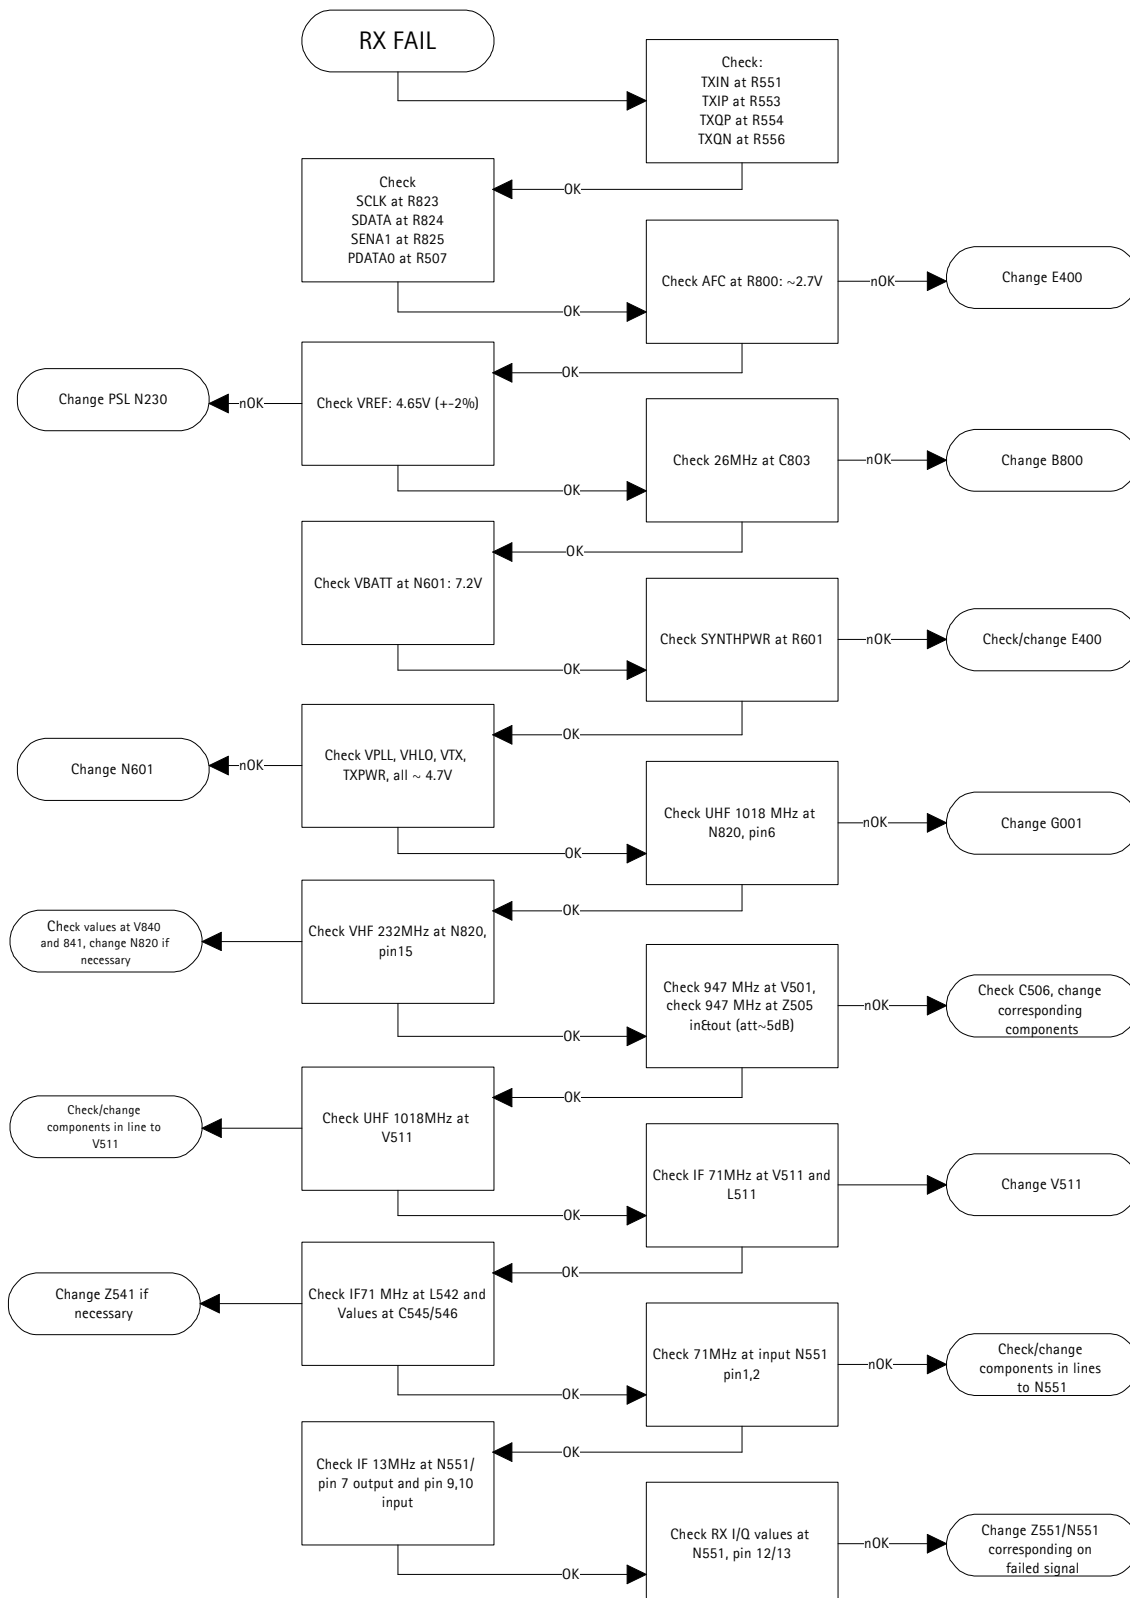
RAE-1

RX failed

Check the TX-spectrum at standard frequency (902MHz /CH 60). If spectrum is ok, check the following points.

If these signals are ok, check the reference frequency of 26 MHz at N820, pin 8, frequency deviation $\leq 50\text{Hz}$., change B800 if necessary.

Check UHF oscillator frequency 1018 MHz at N820, pin 6, change G001 if necessary

Change MCM2 / E400 if one or more of these signals failed

Change corresponding components

Change Z551 / N551 if necessary

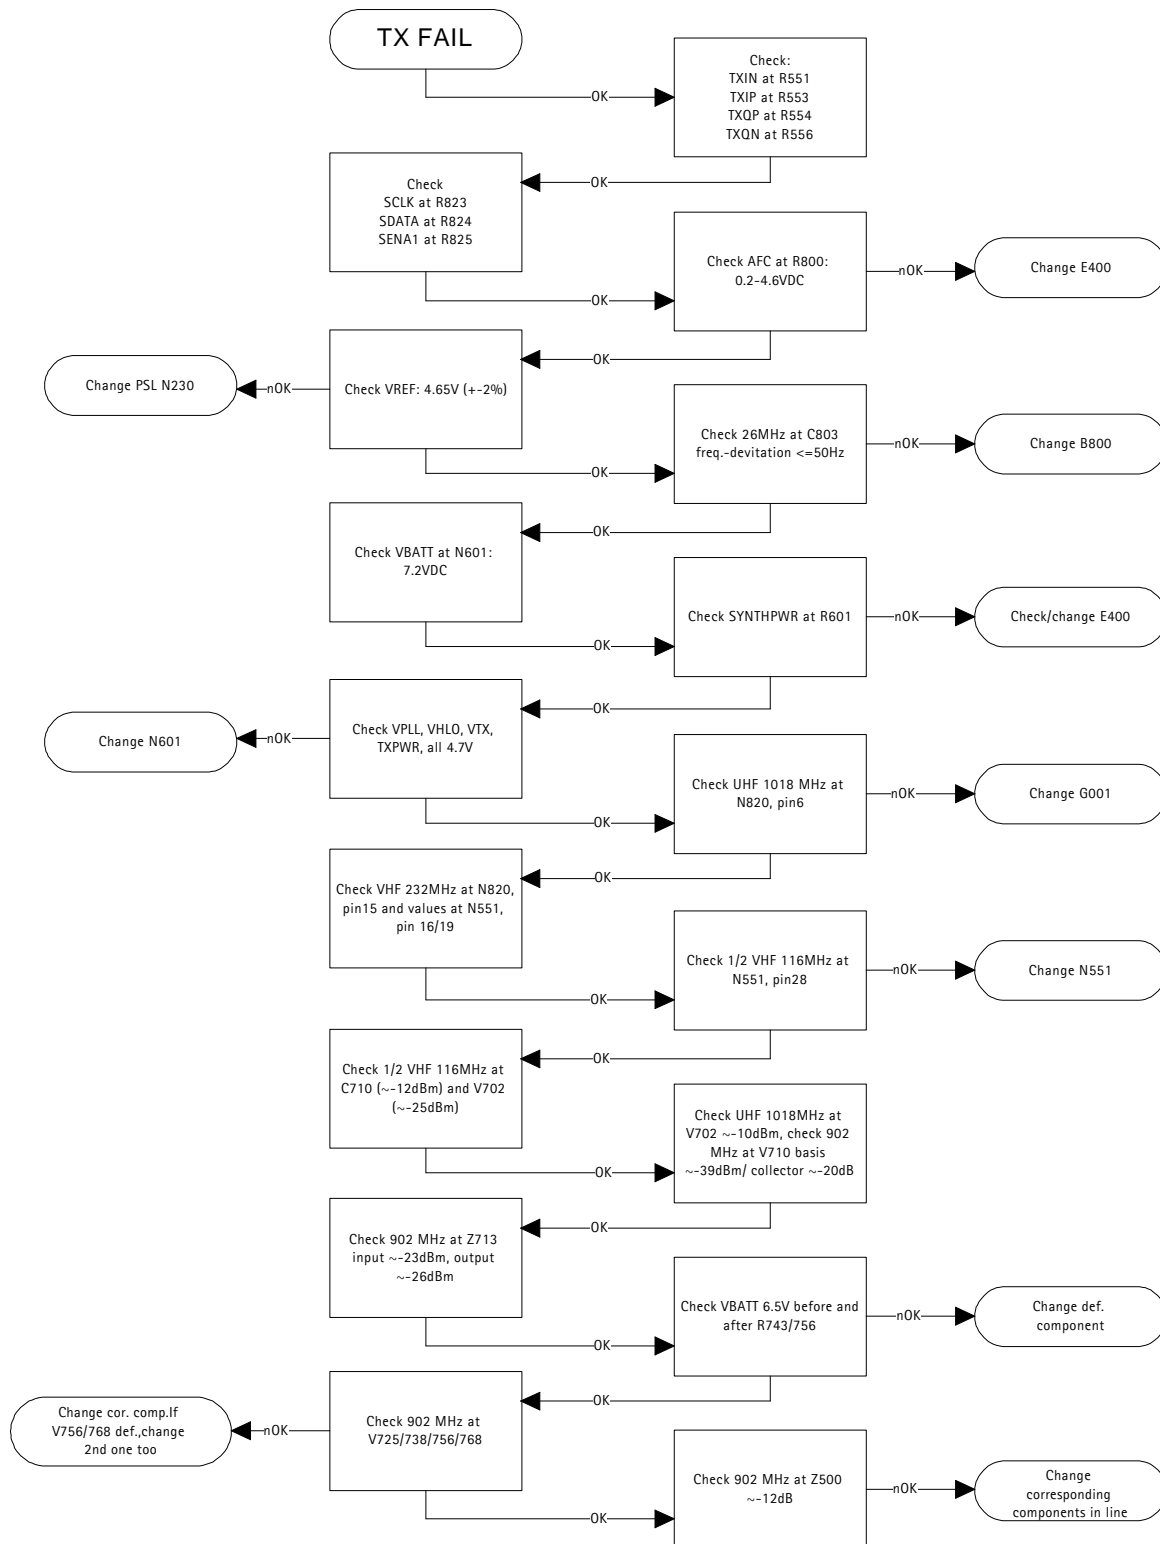
RAE-1

TX failed

If these signals are ok check the reference frequency of 26 MHz at N820, pin 8, frequency deviation $\leq 50\text{Hz}$.

If V756/V768 defect for itself, change the second one as well in every case

Change MCM2 / E400 if one or more of these signals failed

Check 902 MHz at Z500 ($\sim -12\text{dBm}$), change corresponding component(s)

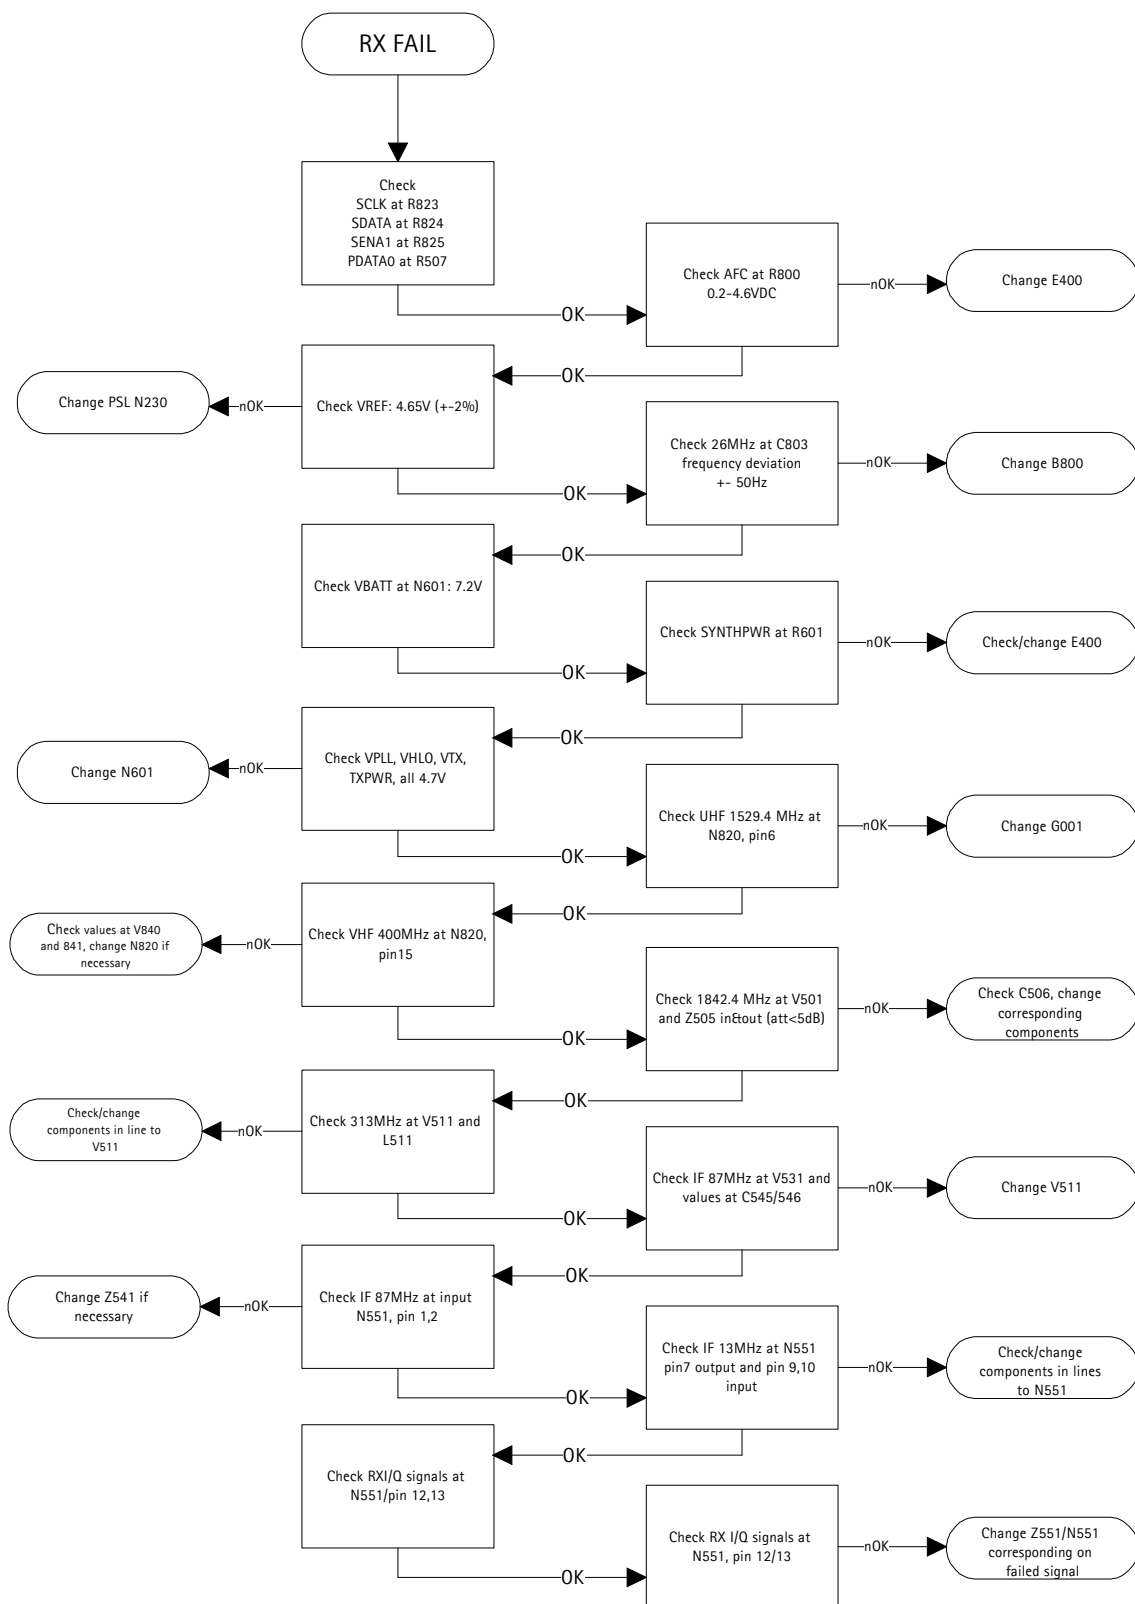
RAK-1

RX failed

If TX spectrum and an RSSI calibration not possible – probably MCM2 / E400 faulty

Change MCM2 / E400 if one or more of these signals failed

Check 13 MHz RXI / RXQ $\sim -21\text{dBm}$ at N551, pin 13,12, change Z551 / N551 if necessary

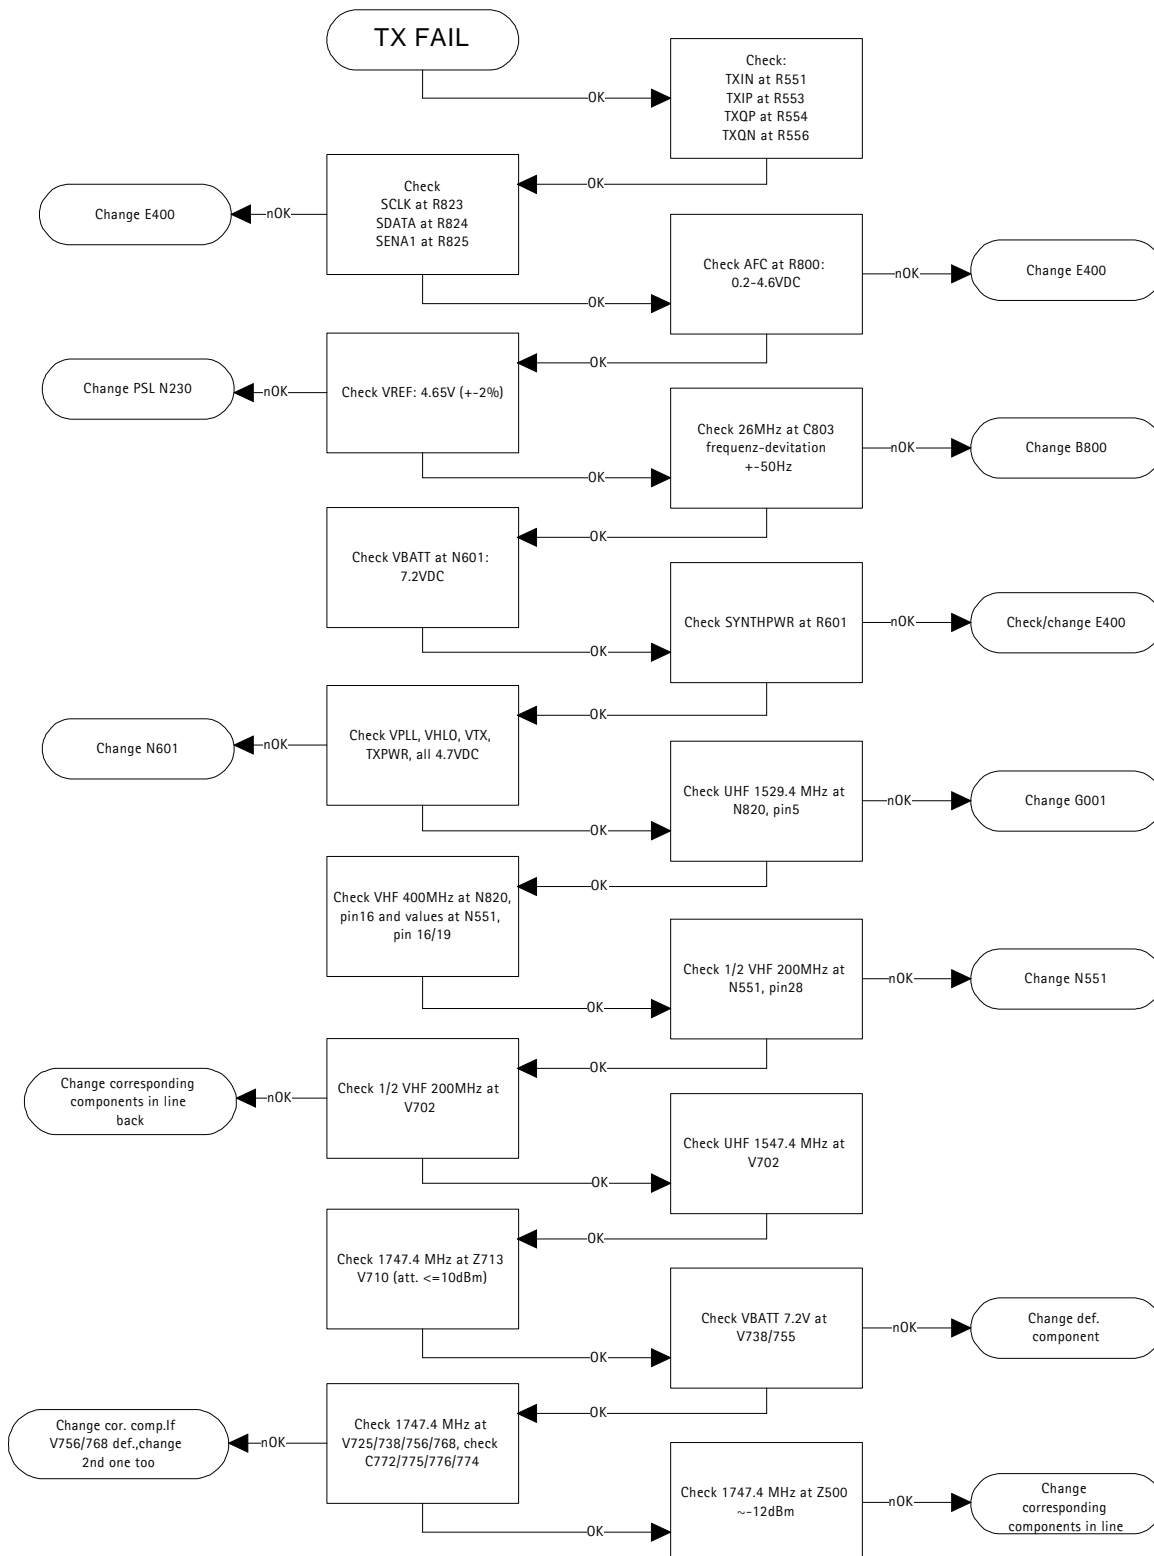
RAK-1

If V756/V768 defect for itself, change the second one as well in every case.

Change MCM2/E400 if one or more of these signals failed.

Check 1747.4MHz at Z500 ($\sim -12\text{dBm}$), change corresponding component(s).

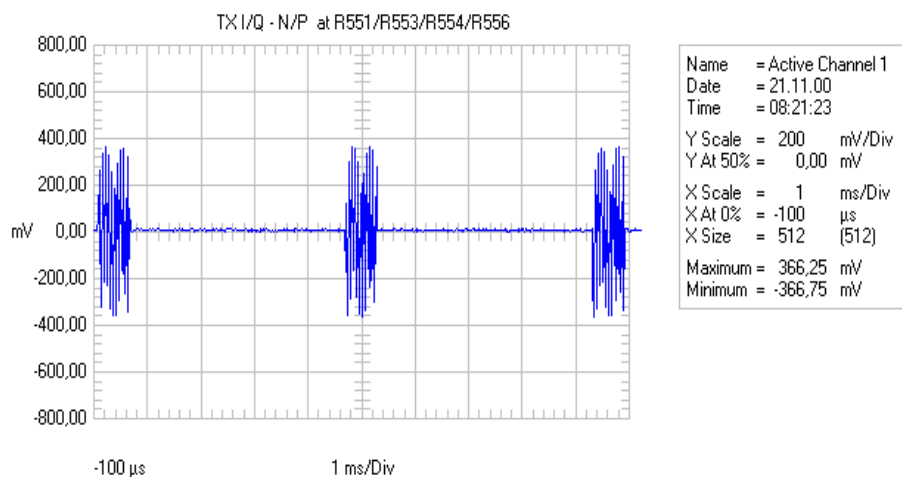
Check TX I/Q signals coming from MCM2 / E400

TXIN	:	400mVpp squarewave at R551
TXIP	:	400mVpp squarewave at R553
TXQP	:	400mVpp squarewave at R554
TXQN	:	400mVpp squarewave at R556
