Date 07.02.97	Ref. No. IP00297	Model CM-DX1000	TD
Subject Disassembly of Set			IRIS

Date 30.05.97	Ref. No. IP00997	Model CM-DX1000	TD
Subject Standby Time Abnormally Short			IRIS 1117

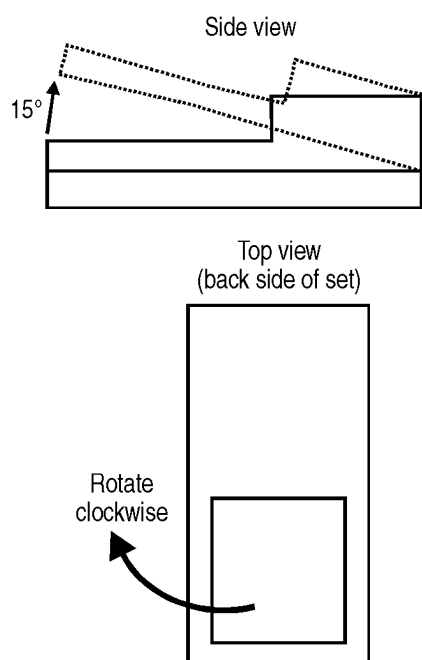
Disassembling the CM-DX1000 may lead to damage of the Upper or Lower Case Shell due to incorrect handling.

The factory assembly of the CM-DX1000 cosmetics is rather tight, and on the upper side, both major parts are held together by claws.

- Remove the Antenna.
- Remove the Battery Cover and the Battery.
- Remove the SIM Card Holder.
- Remove four screws in the Battery Compartment.
- Hold the set in your hand with the display side in the palm of your hand.
- Take the Lower Case Shell at its bottom part (i.e. bottom of the Battery Compartment) and lift this part to an angle of approximately 15°.
- Now rotate the Lower Case Shell clockwise. You will meet some resistance. A loud click will be audible (releasing of the claws) and the Lower Case Shell will be correctly loosened.

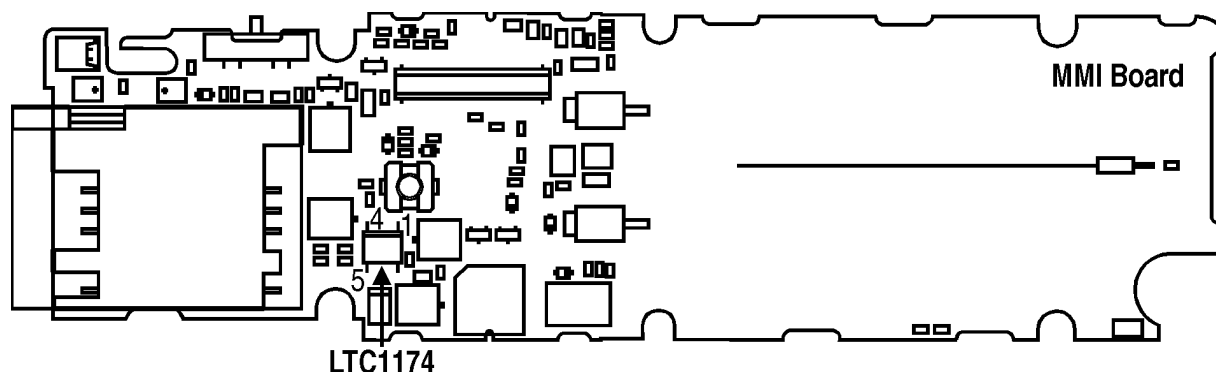
The standby time is abnormally short so that the impression may arise that the battery is defective, or the battery is never totally charged.

Defective IC LTC1147 on the MMI Board.

Replace IC **LTC1147** (8-759-336-22). The part is accessible on the MMI Board after removing the Lower Case Shell and the RF Unit.

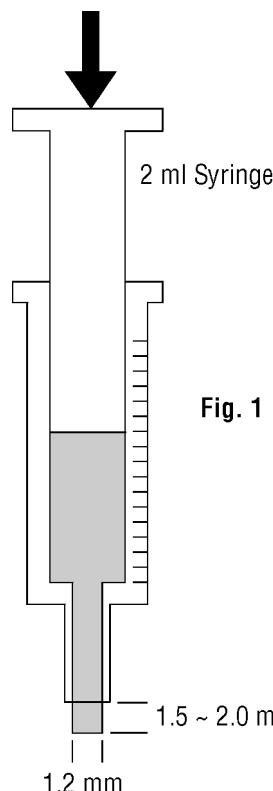
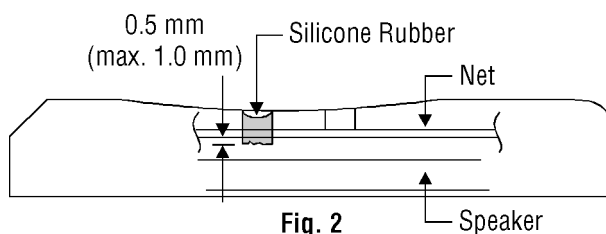
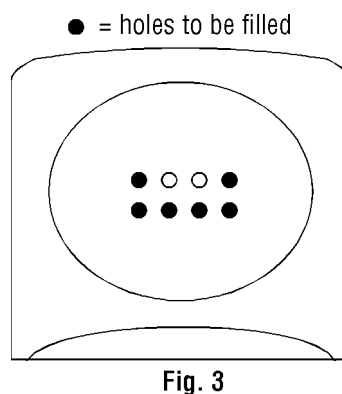
Constant background noise.

Resonance between the Speaker and the Receiver Case.

Modify the Receiver Case (Earpiece Pop-up) by filling six of the eight holes with silicone rubber.

- Apply pressure to the syringe until a small amount of silicone comes out, approx. 1.5 to 2 mm of silicone as shown in Figure 1. This amount is sufficient to fill one hole. Hold the syringe vertical to the hole to be filled and make certain that all of the silicone is pushed inside the hole. The amount of silicone used to fill the hole is critical: if too much is used, the silicone will penetrate the speaker net and might touch the speaker (Figure 2). Repeat the process for all of the six holes indicated in Figure 3.

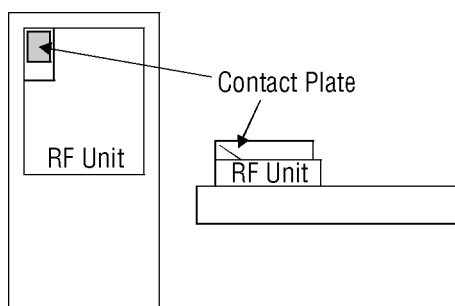
- Loss of network connection.
- No initial connection to network.
- Dropouts during connection.
- Short battery lifetime (due to constant network search).
- Low RF readout in monitor mode.

Poor or no connection between antenna and RF unit.

Check the position of the contact plate on the RF unit. The plate should be correctly soldered and should be pointing upwards.

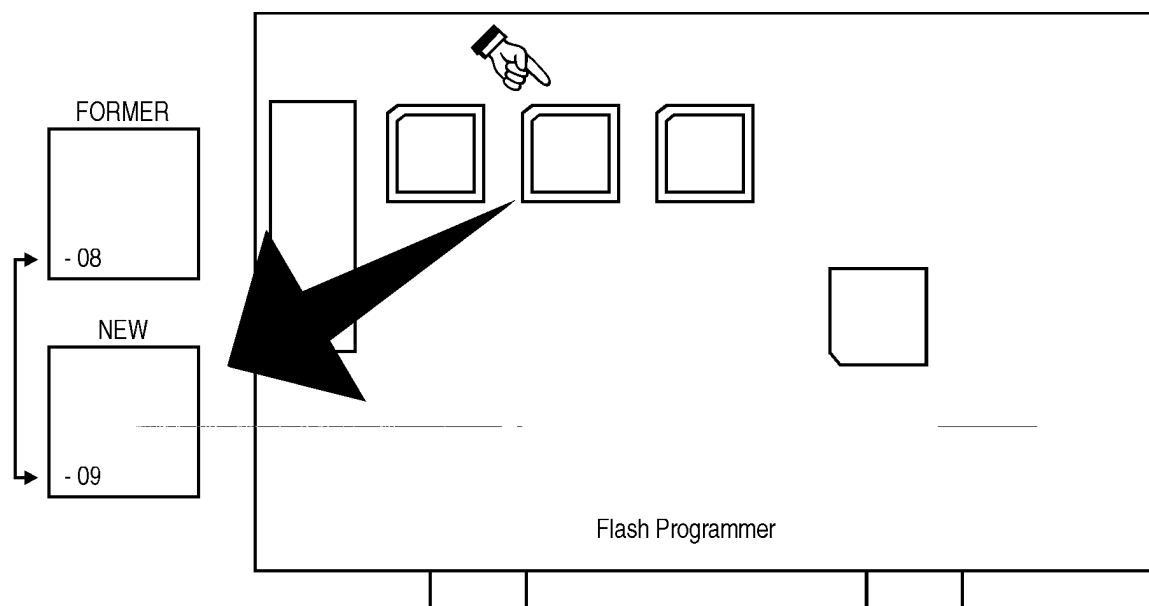
After installing the software upgrade, the set will not work.

New ICs have been used during the production of CM-DX1000. As a result, the Flash Programmer used for software updating needs new operating software.

A new **EEPROM (9-948-004-01)** needs to be mounted in the Flash Programmer. Please follow the instructions listed below very carefully and make sure proper antistatic countermeasures are taken. Note that this new operating software is fully backward compatible. Older GSM units can still be upgraded with this new operating software.

- Remove six screws on the top and four screws at the bottom of the Programmer Box.
- Lift the top housing.
- The EEPROMs are located on the lower PCB.
- **DO NOT ATTEMPT TO DISCONNECT BOTH PCBs AS THE USED CONNECTORS HAVE EXTREMELY FRAGILE PINS !!**
- Move the top PCB gently to the side.
- The EEPROM is mounted on the bottom board in sockets. There are two EEPROMs mounted. It is the left one that needs to be replaced.
- Using an IC Extractor (J-6035-070-A), take out the EEPROM.
- Gently insert the new EEPROM. Be sure to mount it correctly.
- The correct matching is shown on the stickers of the EEPROMs.
