Repairhints

Communicator 9000/9000i RAE/K-1/4

The purpose of this document is to provide some further service information for NOKIA Communicator 9000/I. It contains a lot of collected tips and hints to find failures and repair solutions easily. It also will give support to the inexperienced technicians. Saving process time and improving the repair quality is the aim of using this document. We have built it up based on fault symptoms (listed in "Contents") followed by detailed description for further analysis. It is to be used additionally to the service manual and other service information like Service Bulletins, for that reason it doesn't contain any circuit descriptions or schematics.

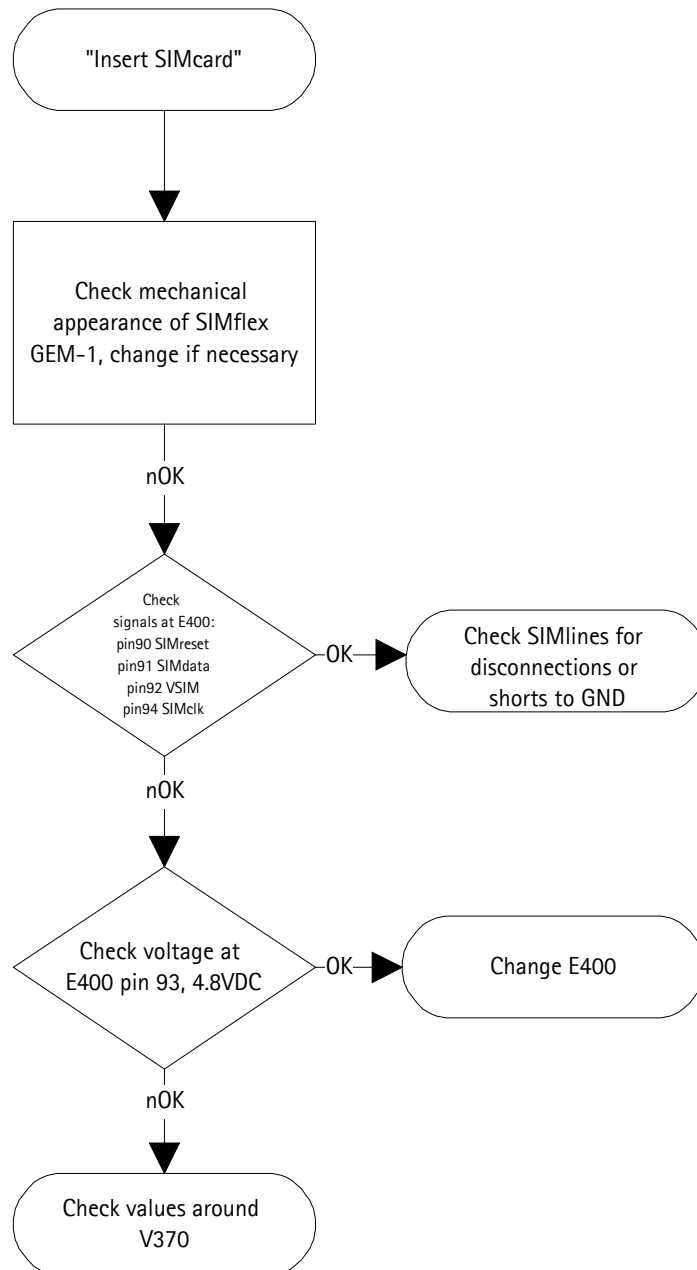
VSIM after switching on the phone without SIMcard. E 400 pulses up VSIM four times to an amplitude of 5 Volt.

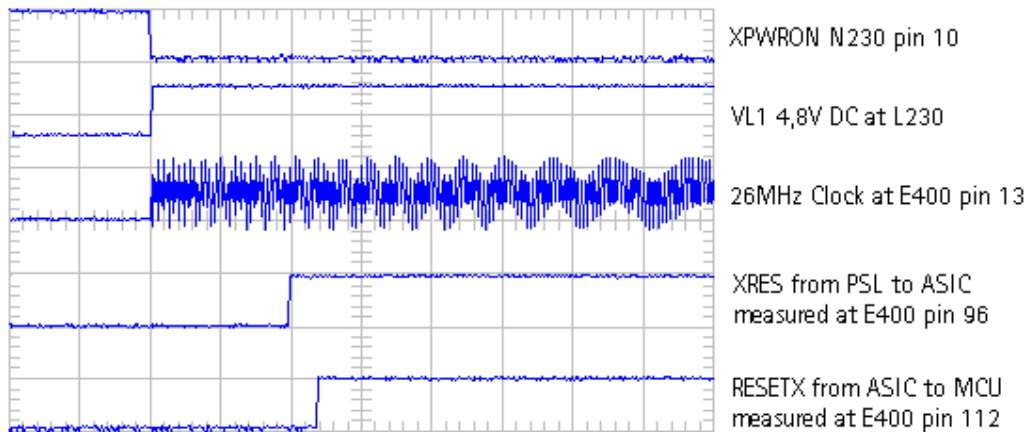
Voltages in the moment of switching on the CMT-part

If CMT does not switch on, it can also be necessary to update the CMT software.
