Date 07.02.97	Ref. No. IP00297	Model CM-DX1000	TD
Subject Disassembly of Set			IRIS

Date 30.05.97	Ref. No. IP00997	Model CM-DX1000	TD
Subject Standby Time Abnormally Short			IRIS 1117

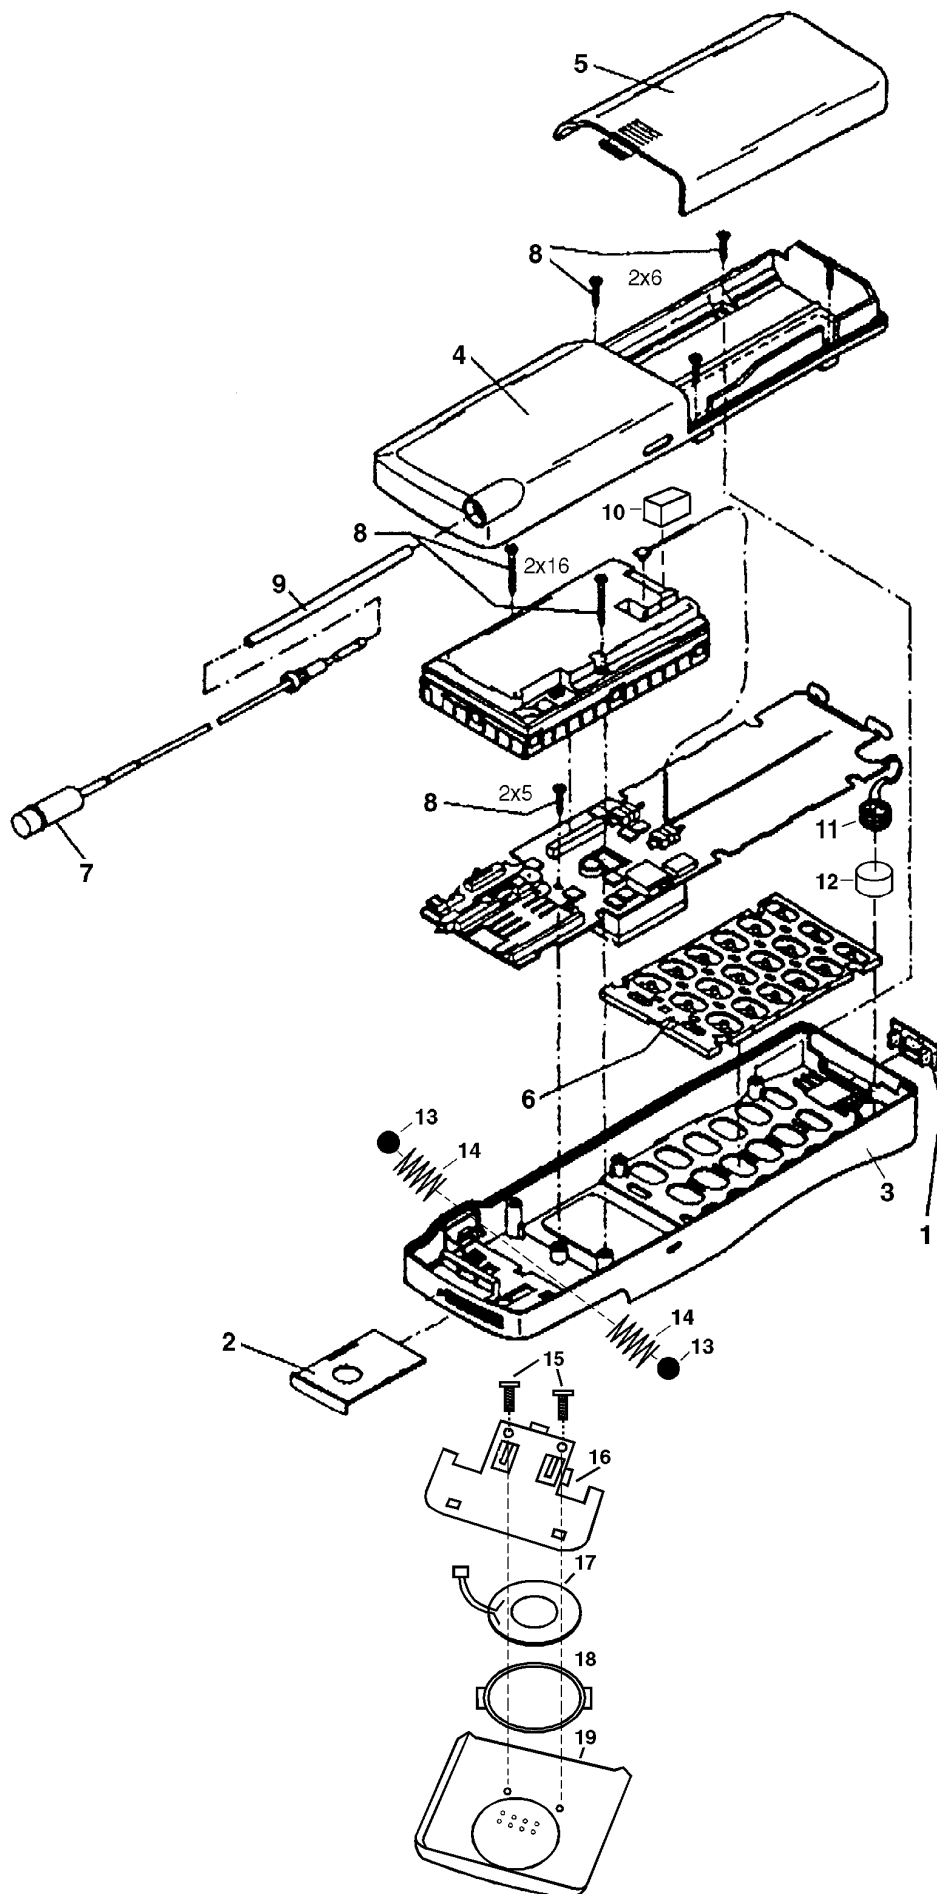
Add the following parts to the exploded view and the parts list.

<i>Ref. No.</i>	<i>Part number</i>	<i>Description</i>
3	X-3369-697-1	Upper Case Shell without Earphone
10	3-923-081-01	Spacer (B)
11	1-542-256-11	Microphone
12	3-920-741-01	Microphone Holder
13	7-671-155-01	Steel Ball (3.0)
14	3-920-743-01	Coil Spring
15	3-920-748-01	Torx Screw (1.7x6)
16	3-920-737-01	Receiver Case (Lower)
17	1-504-764-11	Speaker
18	3-920-740-01	Receiver Holder
19	X-3369-699-1	Receiver Case Subassy
Accessories		
	S-2000-001-0	Instruction Manual (English)
	S-2000-002-0	Instruction Manual (French, Dutch)
	S-2000-003-0	Instruction Manual (German, Italian)
	S-2000-004-0	Instruction Manual (Norwegian, Swedish)
	S-2000-005-0	Instruction Manual (Spanish, Portuguese)
	S-2000-006-0	Instruction Manual (Danish, Finnish)
	S-2000-007-0	Instruction Manual (Greek, Hungarian)
	S-2000-008-0	Instruction Manual (English, Turkish)
Jigs & Tools		
	S-1974-001-0	Antenna Removal Tool

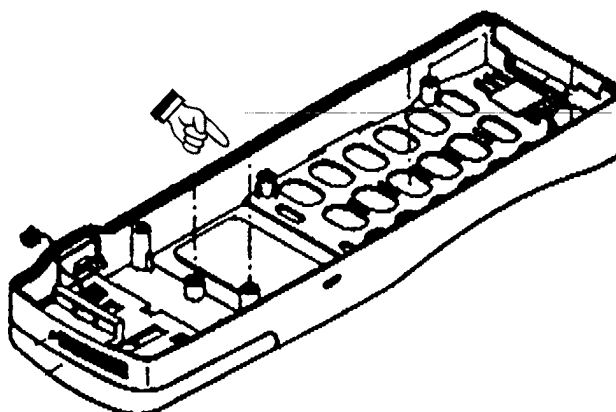
The **Upper Case Shell including Earphone** is now available as part number **A-0602-116-A**.
