# **PAMS Technical Documentation**

## **RPM-1 Series Transceivers**

# **Disassembly and Troubleshooting**

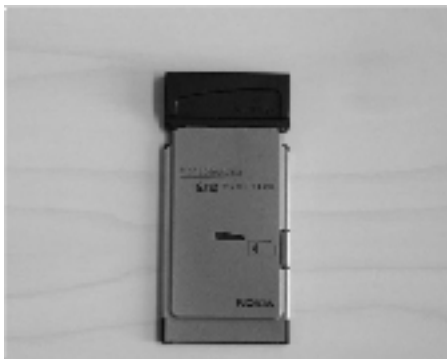
Fig 3. Top view

Do not open Top Cover Printed from left side (top view). Flash component may damage on the PCB.

Open Top Cover Printed only from right side (top view). See picture 3.

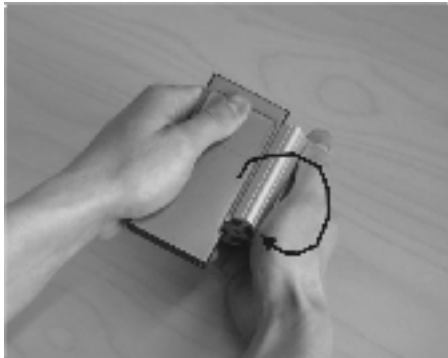
Fig.4. Position of the opening tool

Put the sharp edge of the opening tool to the Top Cover Printed's edge and turn the opening tool smoothly. See picture 4.

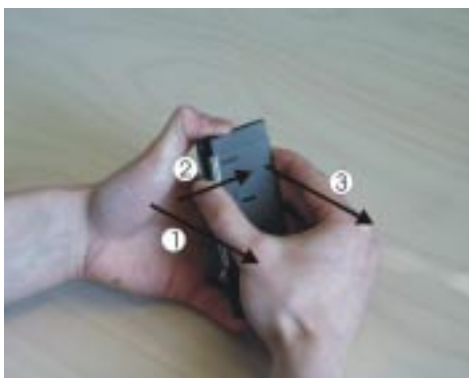
Fig. 5. Open Top Cover Printed

Release the right side of the RPM-1 .

Push Top Cover Printed a little bit to left side after you have opened the right side of the RPM-1 .

Open carefully the Top Cover Printed simultaneously pushing the Top Cover Printed to left side .

See picture 5.

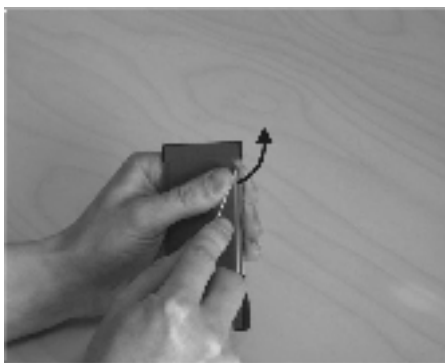
Fig. 7. Position of the screwdriver

Put the screwdriver to the edge of the Top Cover Printed.

Push the Top Cover Printed's edge over the edge of the Bottom Cover subassembly.

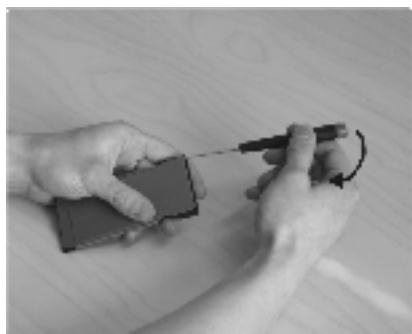
Fig. 8 : Open Bottom Cover subassembly

Push screwdriver (use standard screwdriver ~Ø 1,50 mm) to gap between Extension Box subassembly and Bottom Cover subassembly (left or right side).

Open Bottom Cover subassembly step by step as illustrated in pictures 8 to 9.

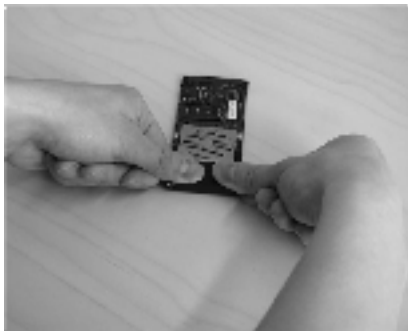
Fig. 13. Push from the Extension Box subassembly

–Put Extension Box subassembly on the Bottom Cover subassembly and push it against table, etc. Push only from the Extension Box subassembly. See picture 13.

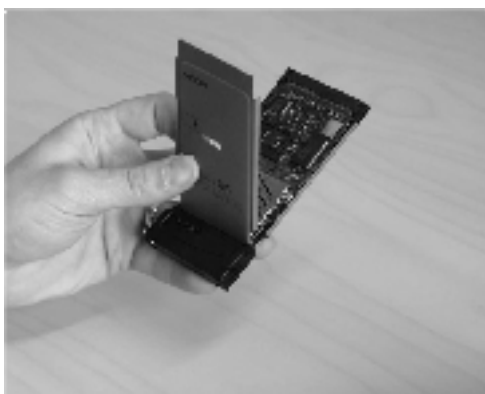
Fig. 14. Assembly angle

Assemble Top Cover Printed to the holes of the Extension Box subassembly. See picture 14.

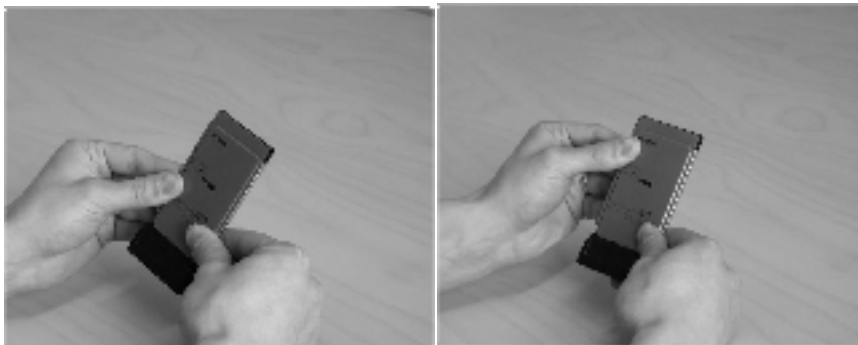
Fig. 16. Close right side

Assemble the right side as the left side was assembled. Start assembly near Extension Box subassembly. See picture 16.
